Figure 5.3: Existing Conditions - 1% AEP Flood Extent and Depths (depths ≥ 50 mm)

TGM Group Pty Ltd Ref: 18231-01
ABN 11 125 568 461 26 Dec 2018

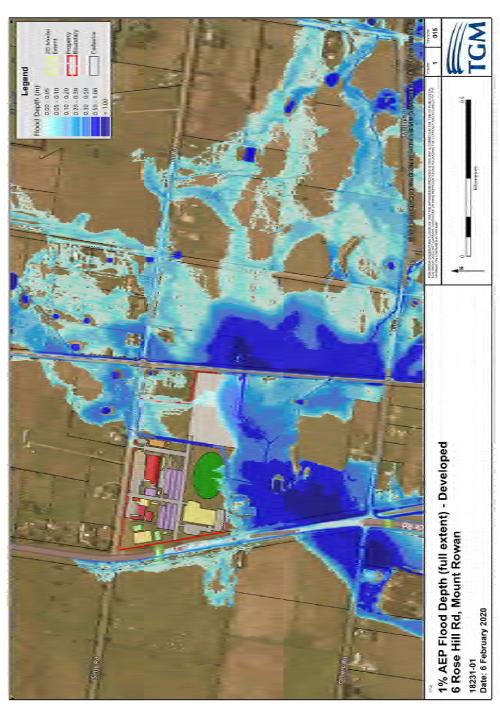
Figure 5.4: Developed Conditions - 1% AEP Flood Extent and Depths

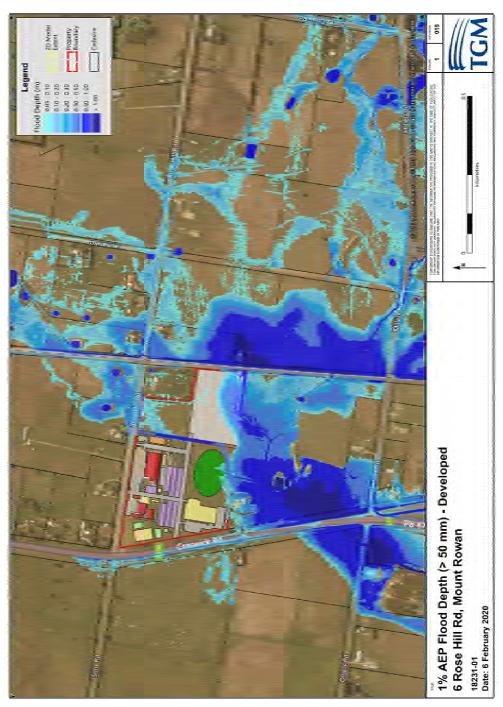
Figure 5.5: Developed Conditions - 1% AEP Flood Extent and Depths (depths ≥ 50 mm)

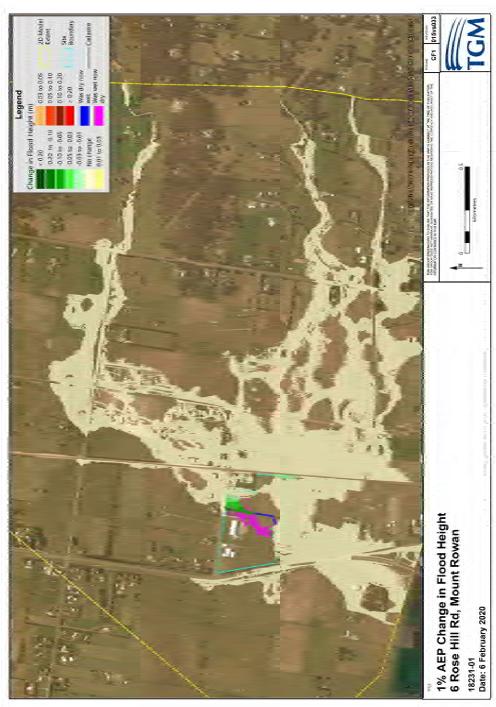
Figure 5.6: Change in Flood Levels - 1% AEP Impact Map

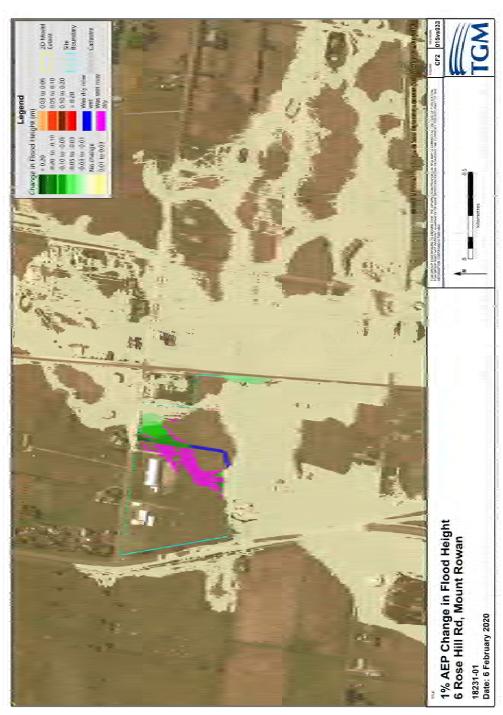
Figure 5.7: Change in Flood Levels - 1% AEP Impact Map (Site)

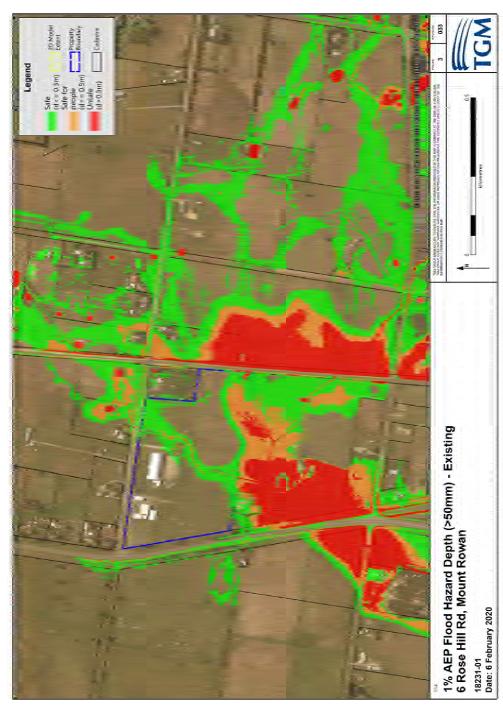
Figure 5.8: Existing Conditions - 1% AEP Depth Hazard

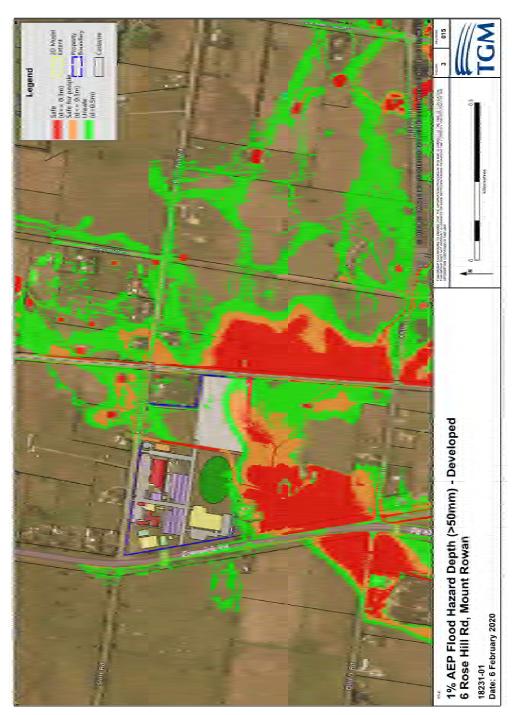
Figure 5.9: Developed Conditions - 1% AEP Depth Hazard

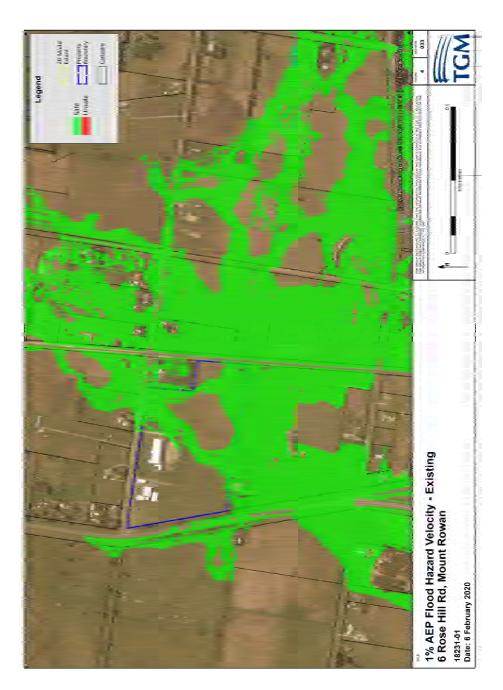
Figure 5.10: Existing Conditions - 1% AEP Velocity Hazard
